# Investment Property Report

**PROPERTY** INV SAMPLE SURVEY  
NOT FOR DISTRIBUTION  
COPYRIGHT SKYLINE  
SURVEYORS LTD

**SURVEY DATE** 1 Oct 2025

**REF** 44940

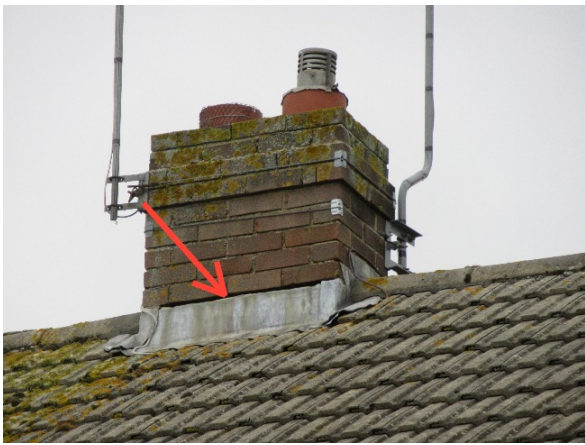
| Element | Picture | Comments | Rating | Cost |
|---|---|---|---|---|
| A : Chimneys | | Stack shared with neighbouring property to the left side. Mortar worn on stack junction with flashing | 3 | 1000 |

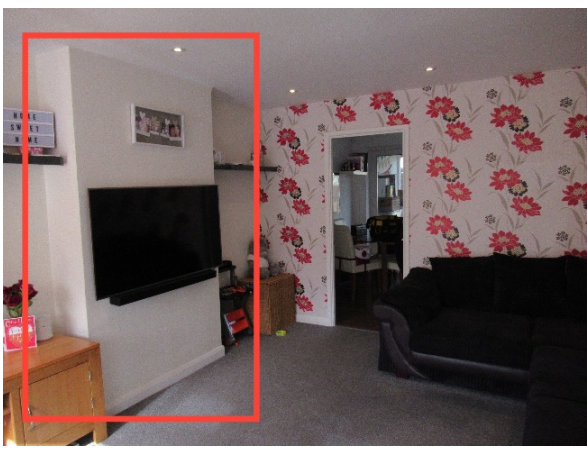
| <p>E: Chimney Breasts</p> | | <p>Chimney breast in living room would benefit from adding some ventilation to the flue that is concealed behind the finished decorations</p> | <p>2</p> | <p>500</p> |

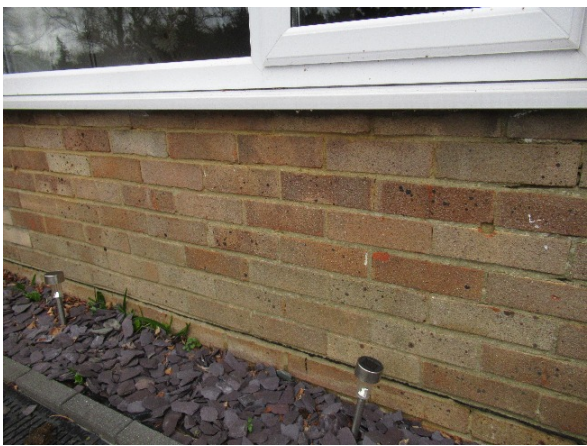
| <p>F: External Walls</p> | | <p>Worn pointing on front lower wall</p> | <p>3</p> | <p>2000</p> |

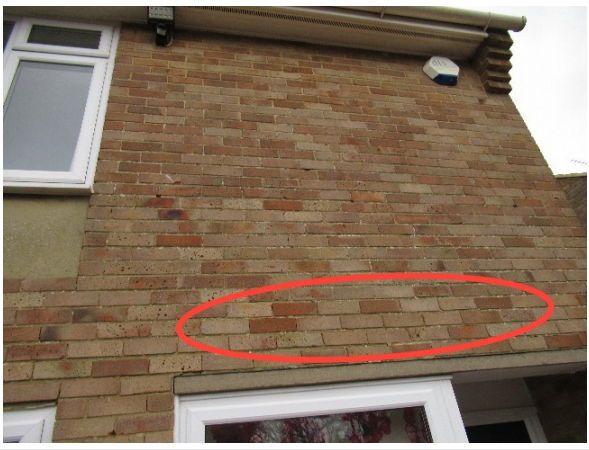
| F: External Walls | | Light wear of the pointing above the front door and adjacent window | 3 | 1500 |

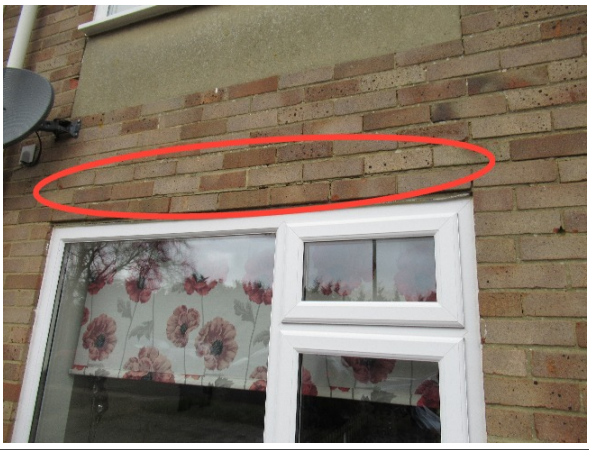
| F: External Walls | | Light wear of the pointing over the front living room window | 3 | 2500 |

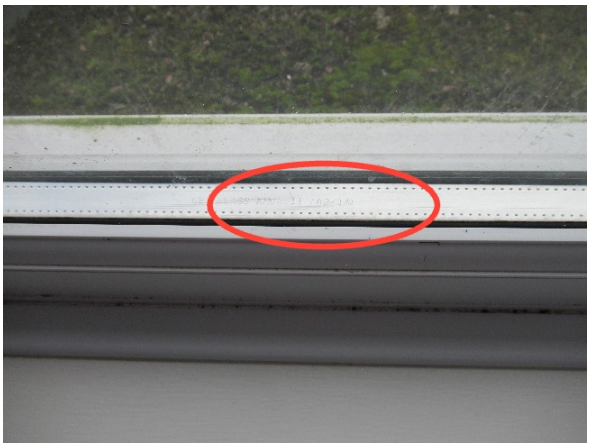
| G: Windows | | Markings in window channels suggests they were replaced in 2014 and FENSA certificates may be required. | 1 | 0 |

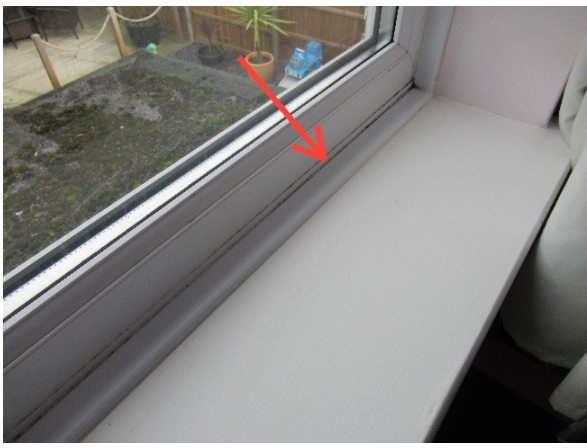
| G: Windows | | Mould growth around window frames suggests some condensation is occurring and more ventilation may be required | 1 | 0 |

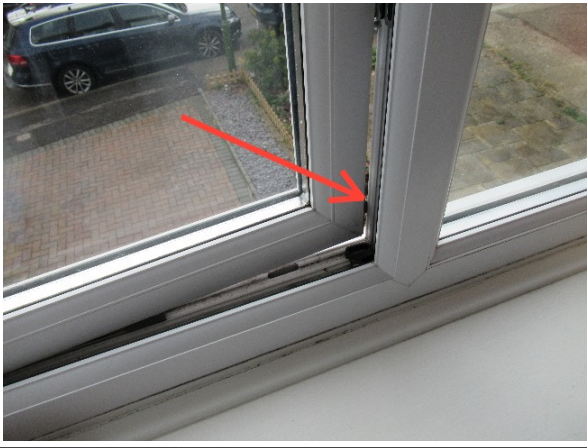
| G: Windows | | Bedroom 1 window catches on frame | 1 | 0 |

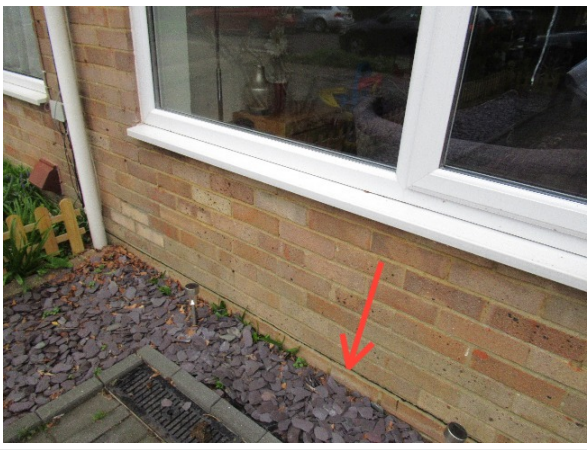
| <p>I: Damp &amp; DPC</p> | | <p>Bitumen DPC visible in the lower walls. No evidence of dampness other than in the conservatory</p> | <p>1</p> | <p>0</p> |

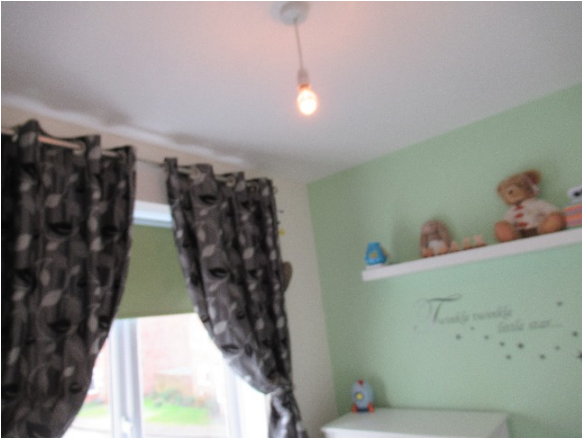
| <p>L: Ceilings</p> | | <p>Some ceilings, such as that in bedroom 3 have textured finishes which can contain asbestos.</p> | <p>1</p> | <p>0</p> |

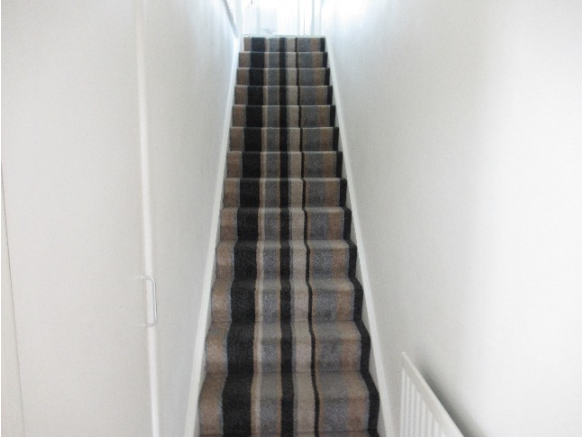
| <p>M: Stairs and Joinery</p> | | <p>The lack of a suitable handrail on the staircase is a safety risk.</p> | <p>1</p> | <p>0</p> |

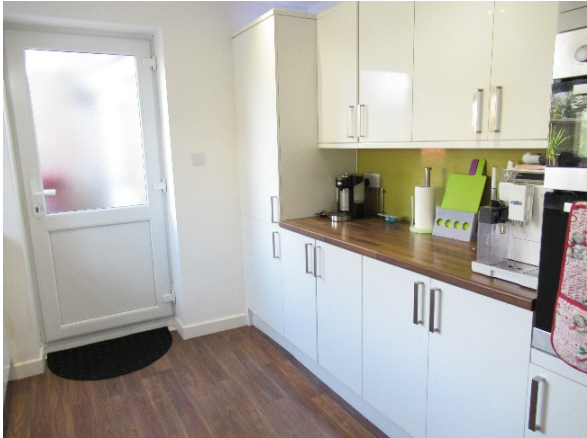
| O: Kitchen Fittings | | Kitchen fittings are in poor condition and require replacement | 4 | 5000 |

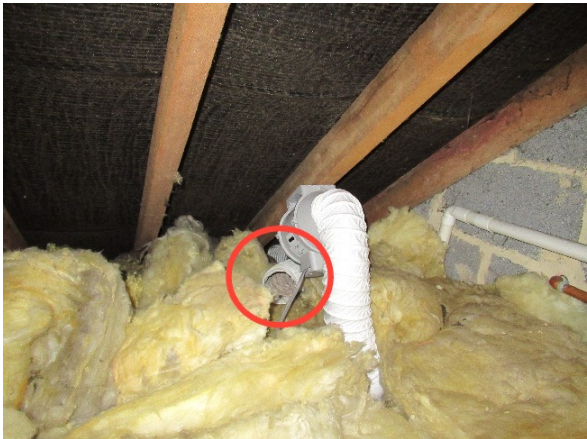
| P: Bathroom Fittings | | The bathroom extractor is not connected to the external vent hose | 3 | 500 |

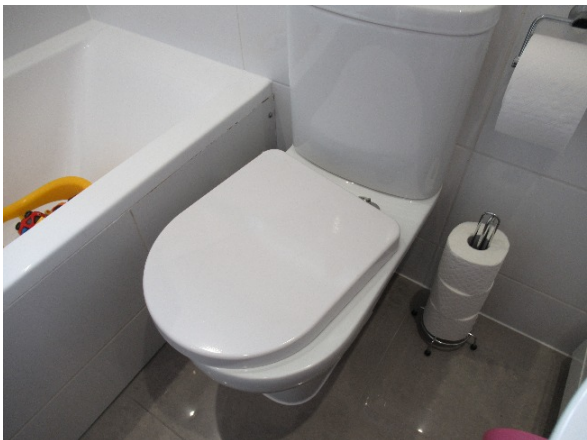
| P: Bathroom Fittings | | Bathroom toilet seat not correctly fixed | 2 | 100 |

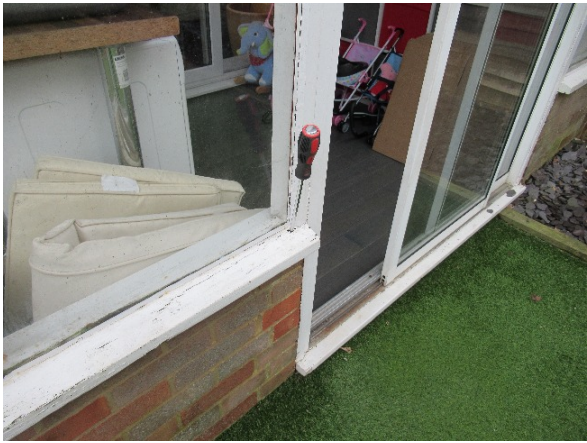
| Q:<br>Conservatory<br>/ Porches | | Rot of conservatory sills | 2 | 1000 |

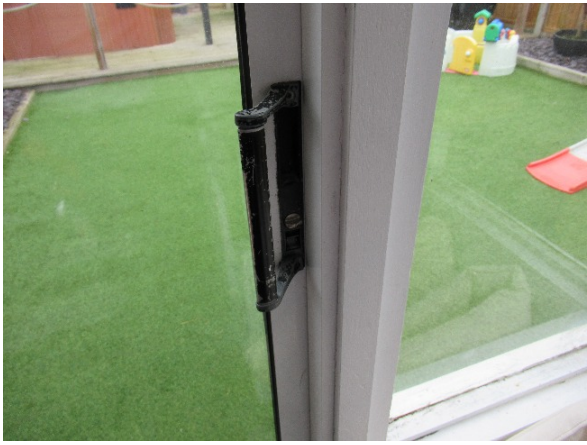
| Q:<br>Conservatory<br>/ Porches | | Conservatory external rear door does not lock | 2 | 1000 |

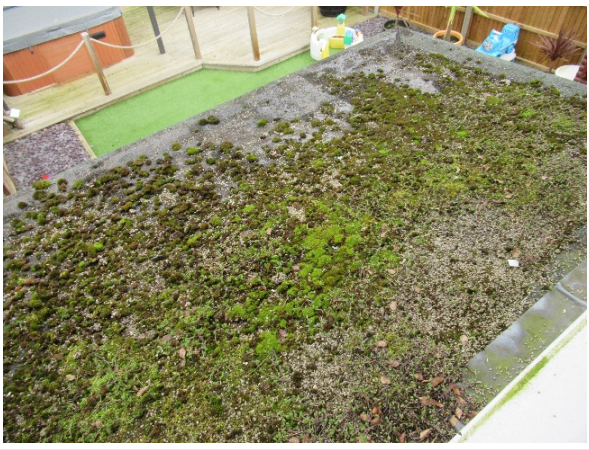
| <p>Q:<br/>Conservatory<br/>/ Porches</p> | | <p>Heavy moss growth on the conservatory roof indicates a lack of proper drainage, probably due to an inadequate fall. It is likely that this will lead to premature failure of the roof covering</p> | <p>4</p> | <p>2000</p> |

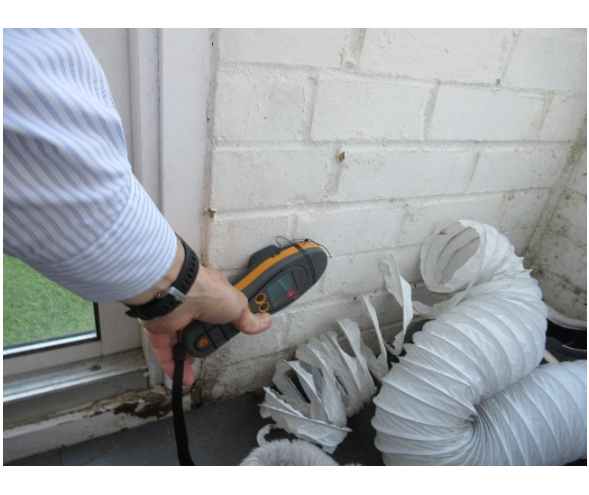
| <p>Q:<br/>Conservatory<br/>/ Porches</p> | | <p>Dampness was detected on the back wall of the conservatory. This is most likely due to the construction of the lower walls which is of a single leaf of solid brickwork, probably made worse by poor ventilation when running the tumble dryer.<br/>The only practical way to resolve this would be by replacing the conservatory entirely, or with some significant alterations to the insulation of the conservatory.</p> | <p>4</p> | <p>2500</p> |

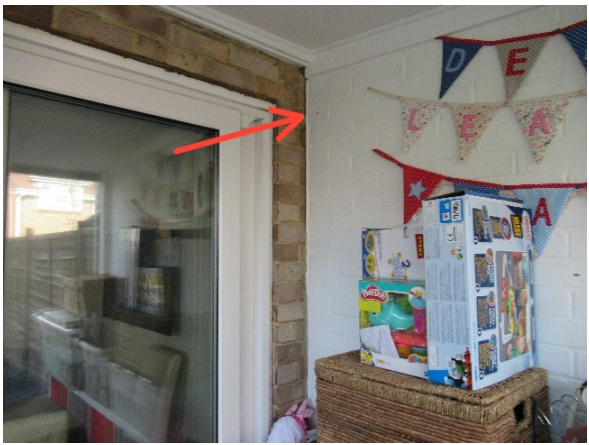
| Element | Comments | Rating | Cost |
|---|---|---|---|
| Q: Conservatory / Porches | Evidence of some separation of the conservatory from the main building, likely due to thermal movement that results from the different constructions of the main house and conservatory. This suggests that replacement of the conservatory would be the best option in the long term | 4 | 25000 |

| <p>Q:<br/>Conservatory<br/>/ Porches</p> | | <p>Evidence of some separation of the conservatory from the main building, likely due to thermal movement that results from the different constructions of the main house and conservatory. This suggests that replacement of the conservatory would be the best option in the long term</p> | <p>4</p> | <p>25000</p> |

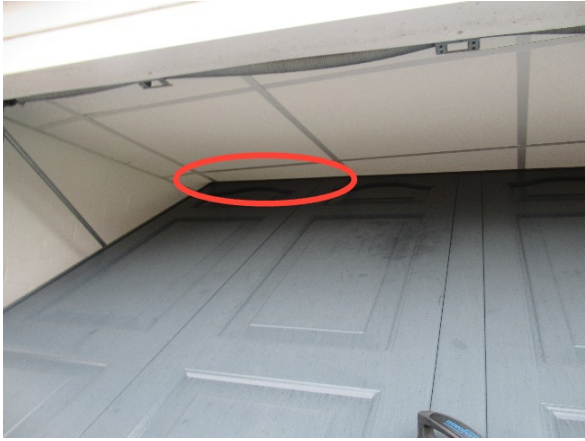
| R: Garages / Outbuildings | | Garage door fouls on roof panels when opening | 2 | 500 |

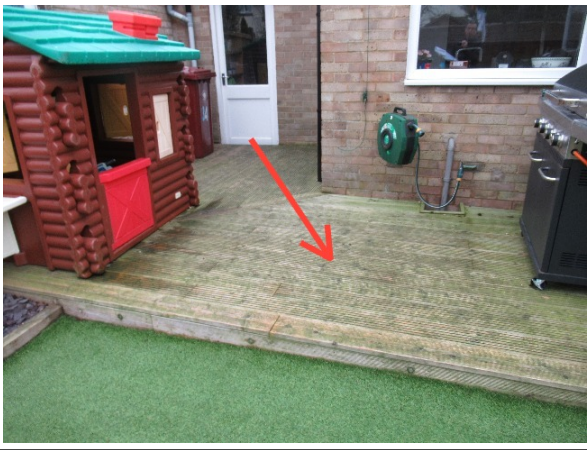
| <p>S: Paths,<br/>Hardstanding<br/>and<br/>Boundaries</p> | | <p>Rear decking likely to be very slippery when wet</p> | <p>HS</p> | <p>0</p> |

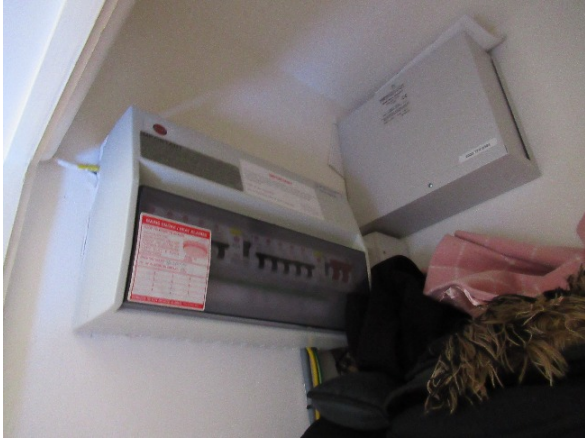
| W: Electricity | | Modern consumer unit. A label indicates that the electrical installation may have been inspected in April 2014. You should get the installation tested. | HS | 500 |

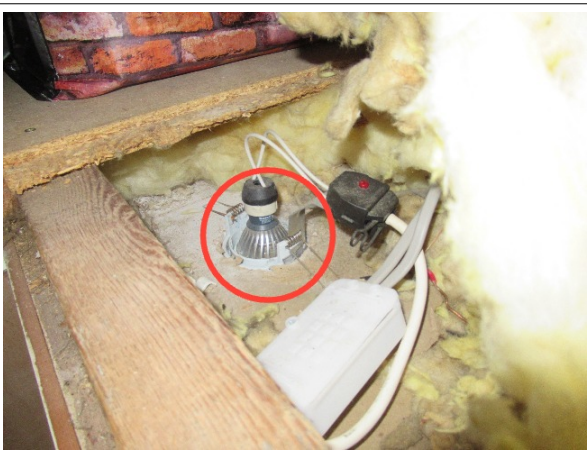
| <p>X : Other</p> | | <p>No intumescent hoods over downlights in roof space</p> | <p>HS</p> | <p>250</p> |
